FIELD STUDY OF FENCING MATERIALS IN A MARINE-ATMOSPHERIC ENVIRONMENT -
RESULTS OF UP TO THREE YEARS OF ATMOSPHERIC EXPOSURE AND CORROSION RATE
DETERMINATION

Technical Note N-123

Eddy S. Matsui

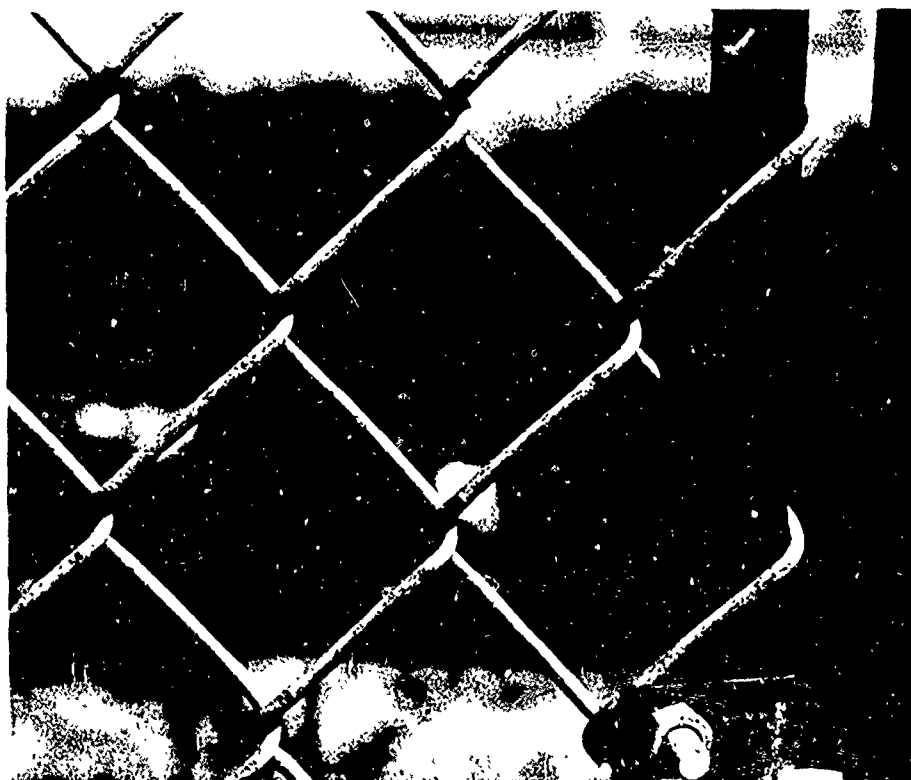
Systems 1 and 2 - Light and Heavy Zinc-coated Fabrics: The surface of the zinc-coated fabrics exhibited a bright metallic appearance when inspected at the time of installation (Figure 3). At the time of the fifth inspection (2 years after installation), the surface of both fabrics were nearly completely covered with a white corrosion product, a blend of fine air-borne sand and dirt that formed a rough surface on the fence wire. Very faint speckles of rust stains, in the form of pin-hole rust, appeared on the surfaces of the wire. Some of the rust stains were superficial and were probably caused by iron contaminated air-borne sand and dirt. The air-borne sand and dirt accumulated on the windward side more than the leeward side of the wire.

Figure 3. System 1. Newly installed zinc coated steel.

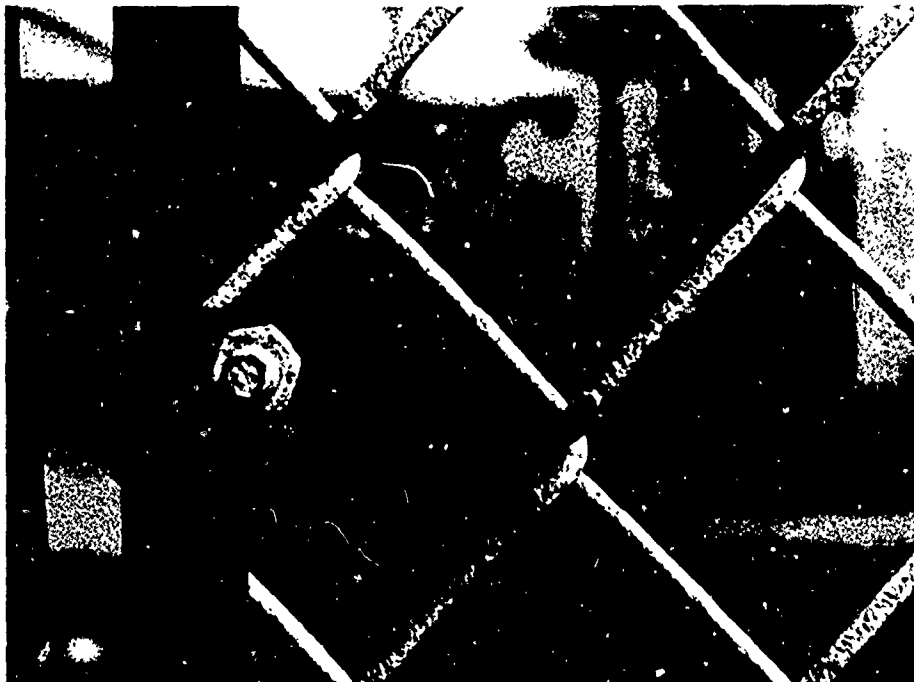
At the sixth inspection (3 years after installation), the zinc coating on the wire seemed to have disappeared, and only a dark gray zinc-iron alloy remained under the white corrosion product. Speckled rust stains were more apparent compared to the previous inspection and were distributed uniformly over about 5% of the zinc-coated surface (Figure 4). A little more of the rust stains were observed on wires located near the water than on those located away from water. The zinc-coated wires tarnished and corroded much faster than they normally would in a non-maritime environment. This was readily evident when comparing the test fence against a similar fence at a public school which was located 10 miles inland from the shore. After five years of atmospheric exposure, the school yard fence had tarnished to only a gray color and there was no accumulation of the white coarse corrosion product (Figure 5).

Although the corrosion products had accumulated and covered the entire wire surface of both systems, the performance of the zinc-coated wire for the first 3 years was rated fair because there was no significant amount of red rust formed on the base metal. Overall ratings are summarized in Table 3.

Figure 4. System 1. Zinc-coated steel - after 3 years of exposure.

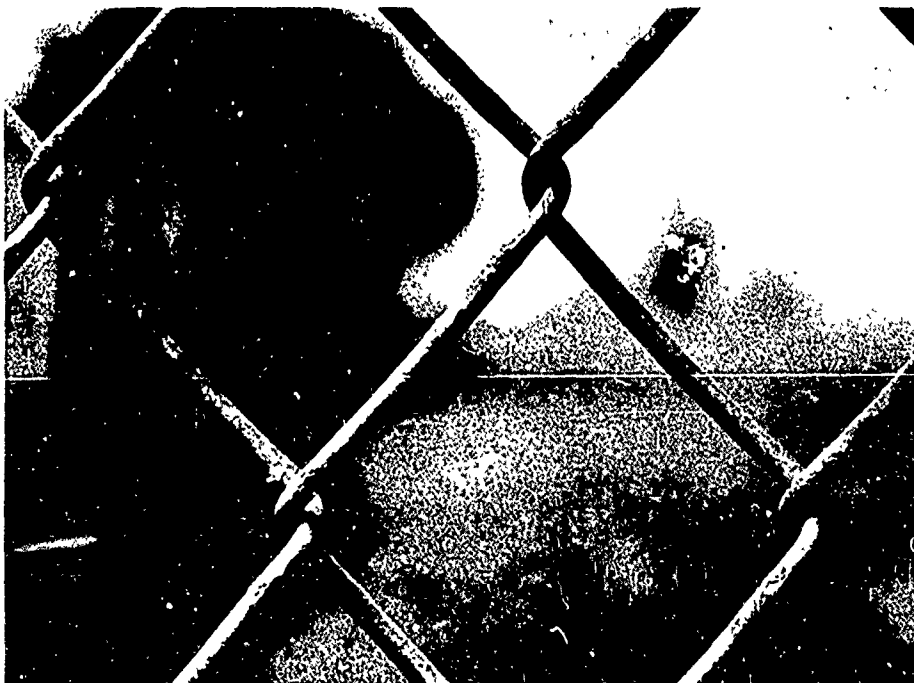
Figure 5. Zinc-coated steel - after 5 years - located 10 miles inland from shore.

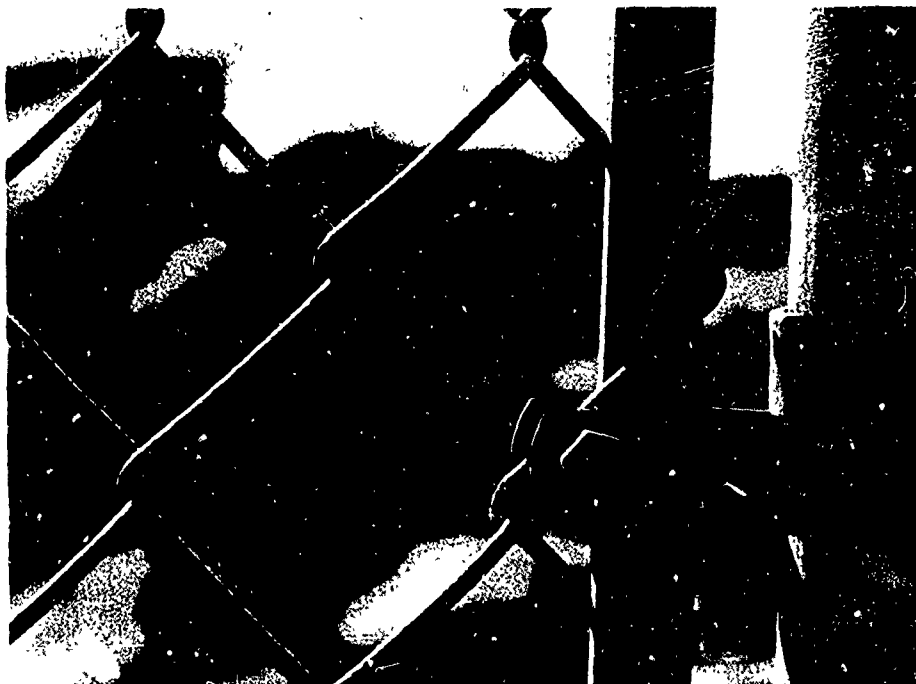
Systems 3 and 4 - Light and Heavy Aluminum-coated Fabrics: The bright metallic appearance of the aluminum-coated wires (Figure 6) diminished rapidly as the exposure test continued, and the surface of the wire was rapidly covered with white corrosion products. The corrosion products were coarse and consisted of white loosely-adhering crystals, which crumbled easily when rubbed between the fingers.

Figure 6. System 3. Newly installed aluminum-coated steel.

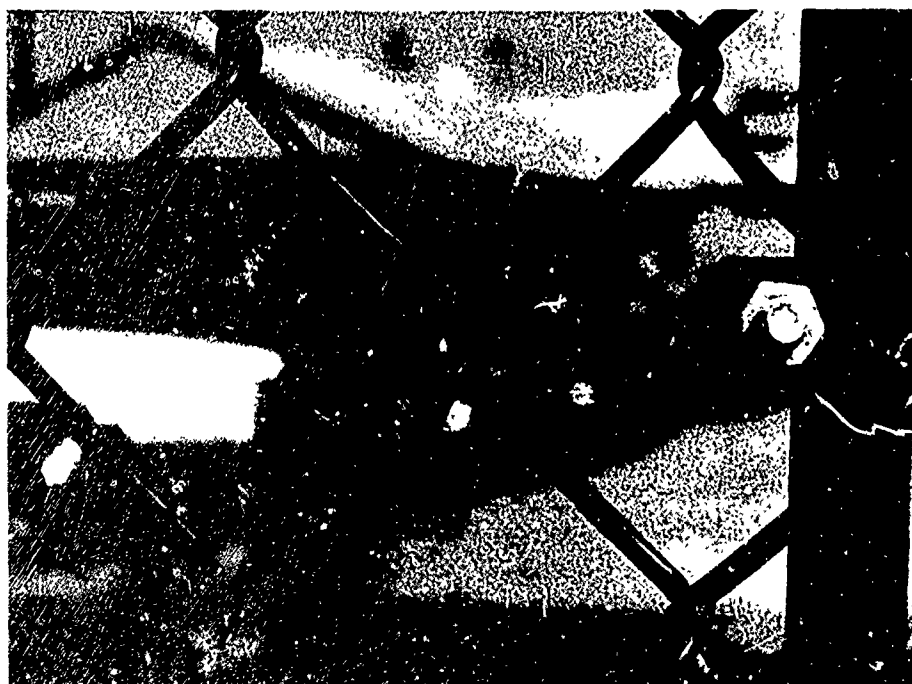
Systems 5 and 6 - Vinyl-clad Galvanized Steel Fabric: After the 3 years of exposure there was no evidence of cracking, color-fading, or any other visible form of deterioration in the polyvinyl chloride covering. Accumulations of air-borne sand and dirt on the wires were quickly washed away after each rainfall and the appearance of the fabric was as good as when installed (Figures 8 & 9). The white corrosion product observed at the cut-end is considered normal for this type of fencing and it did not corrode any further nor cause any rust stains.

Figure 9. System 5. Vinyl-clad galvanized steel - after 3 years of exposure.

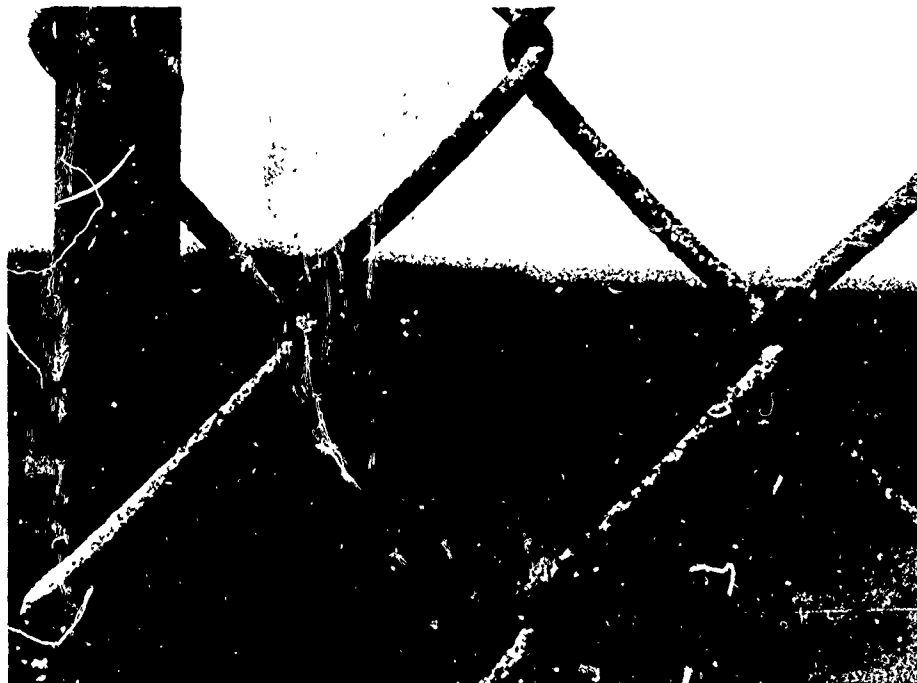
System 8 - Aluminum Alloy Fabric: During the three years of exposure, the bright metallic appearance of the aluminum alloy wire (Figure 11) was gradually lost by the accumulation of white corrosion product (Figure 12). The accumulation rate of the whitish corrosion product was slightly slower than that of the aluminum-coated wires, Systems 3 and 4.

Figure 12. System 8. Aluminum alloy after 3 years of exposure.

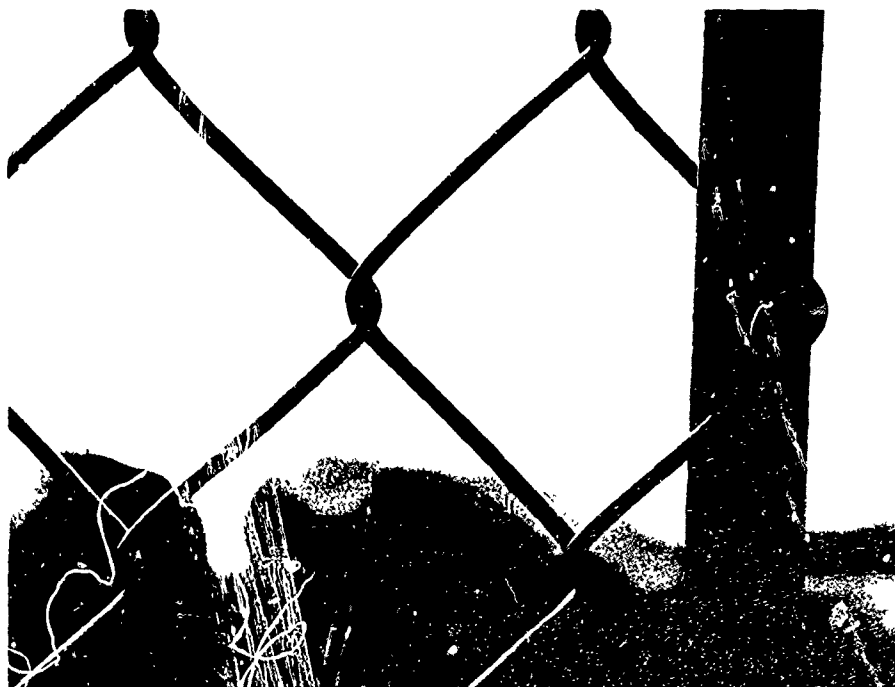
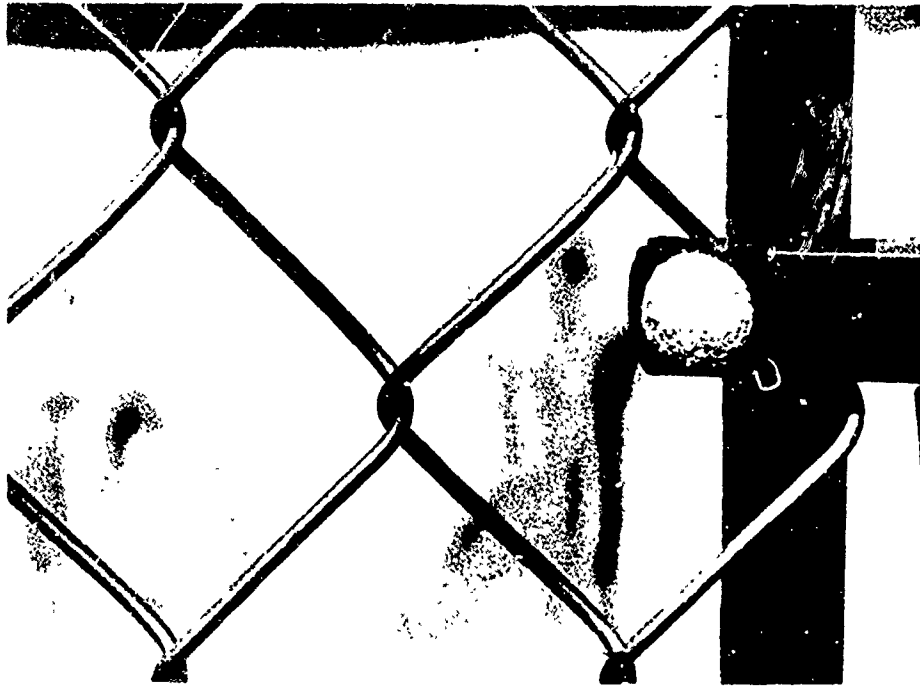
System 9 - Stainless Steel Fabric: The stainless steel fabric maintained its bright metallic appearance (Figures 13 & 14) throughout the three years of exposure. However, some of the accumulated sand and dust on the fabrics were not washed away easily following each rainfall and gave a rusty appearance.

The overall performance of the stainless steel fabrics was rated excellent.

Figure 13. System 9. Newly installed stainless steel.

Figure 14. System 9. Stainless steel after 3 years of exposure.

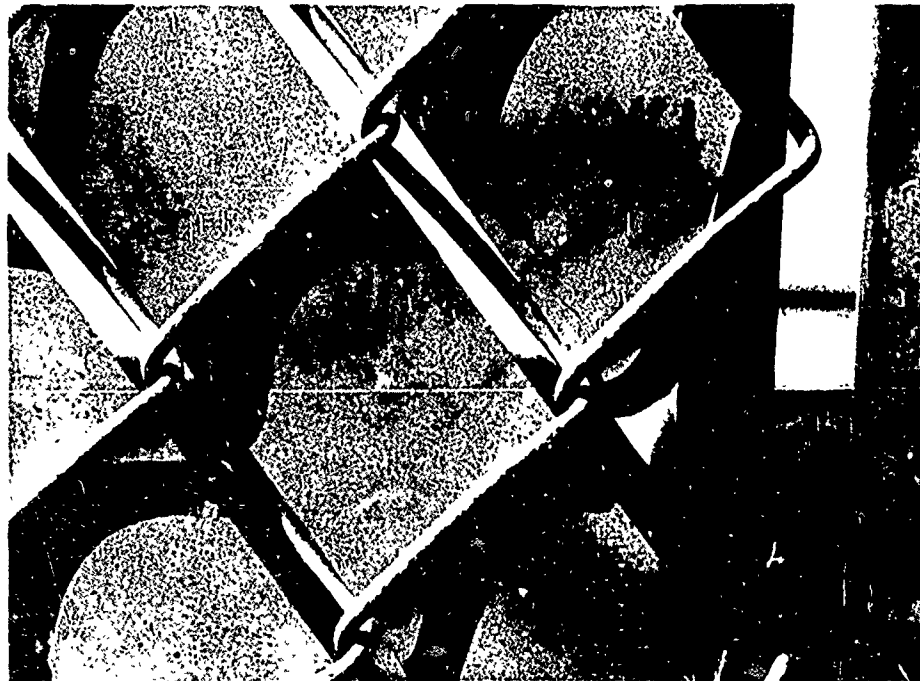
Systems 10, 11, 12 and 13 - Fence Fabrics with Slats: After 3 years of exposure, none of the anodized aluminum slats in System 10 showed any sign of corrosion (Figures 15 & 16). The redwood pickets in System 11 showed no sign of deterioration for the first three years of exposure except a slight fading of color (Figure 17). The condition of the zinc-coated fabrics with anodized aluminum and redwood slats (Systems 10 & 11) was slightly better than that of the zinc-coated fabric without the slats (System 2). The wires accumulated less white corrosion product, fine sand, and dirt. This is probably due to the shielding effect of the slats. Contact between the aluminum slats and zinc-coated wire did not appreciably affect the corrosion process.

Figure 15. Newly installed anodized aluminum slats on zinc-coated wire.

Figure 16. System 10. Anodized slats and zinc-coated wire after 3 years of exposure.

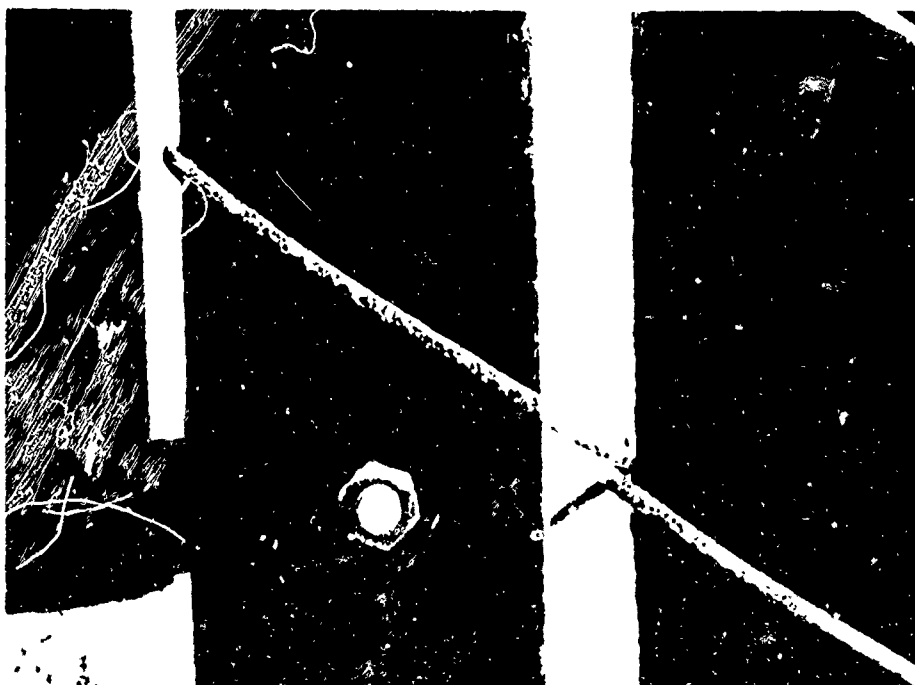
Figure 17. System 11. Redwood slats with zinc-coated wire after 3 years of exposure.

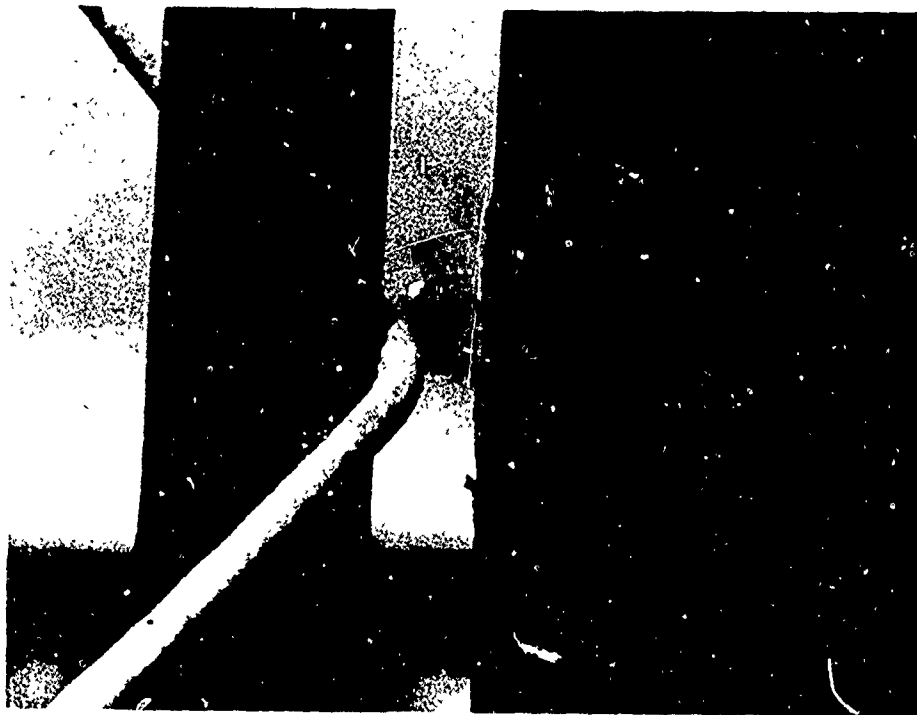
When the vinyl coating was mechanically damaged it resulted in adverse effects on the post and accessories. Blistering and corrosion took place rapidly in the damaged areas (Figure 20). However, the post and accessories in which galvanized steel was under the vinyl coating, were protected from corrosion attack where the covering was damaged by mechanical forces (Figure 21).

Figure 20. Blister formation on mechanically abraded area.

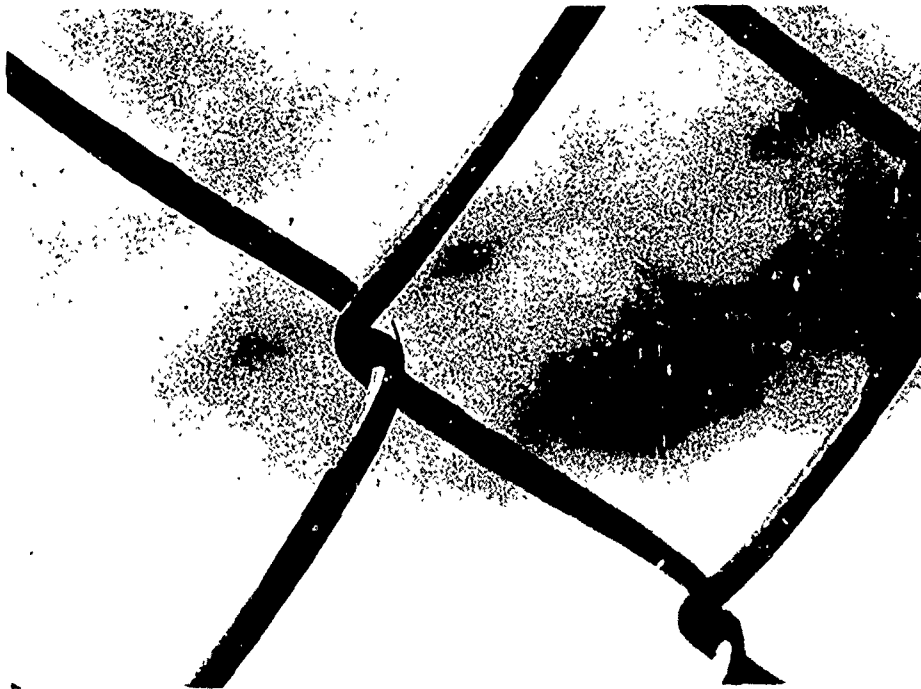
During the 12 months of atmospheric exposure, the fabric showed no evidence of cracking, color fading, or any other form of visible deterioration in the vinyl-coating (Figure 22). However, rust and blisters appeared in the areas where the fabric was damaged by an external mechanical force.

Except for the damaged areas, the performance of the vinyl-coated fabrics were rated excellent during the first 12 months of exposure.

Figure 22. System 14. Blister formation around damaged area - after 12 months of exposure.

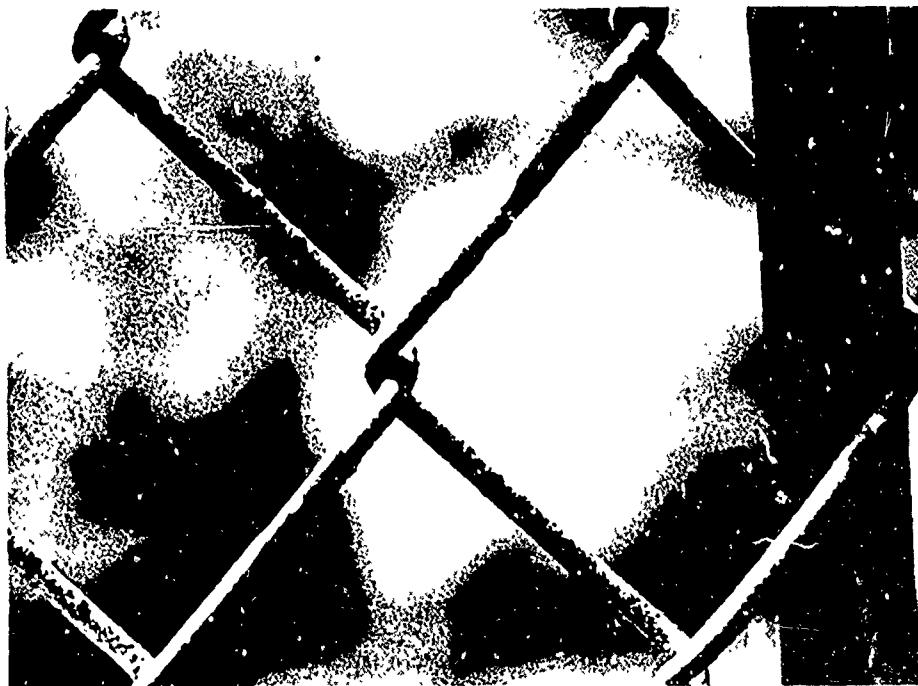
System 15 - Aluminum-welded Chain-link Fabric: Although this material is somewhat similar to the aluminum-clad fabrics, (Systems 3 & 4), the resistivity to corrosion of this fabric appears to be much superior than the two forementioned fabrics. After 12 months of exposure, the accumulation of corrosion products on System 15 were much less (Figure 23) than that of Systems 3 and 4 which were completely covered with a white corrosion product (Figure 24). Approximately 40% of System 15's surface, mostly on the windward side of the fabric, was covered with the white corrosion product. There were no visible red rust stains on the wires.

Figure 23. System 15. Aluminum-welded steel - after 12 months of exposure.

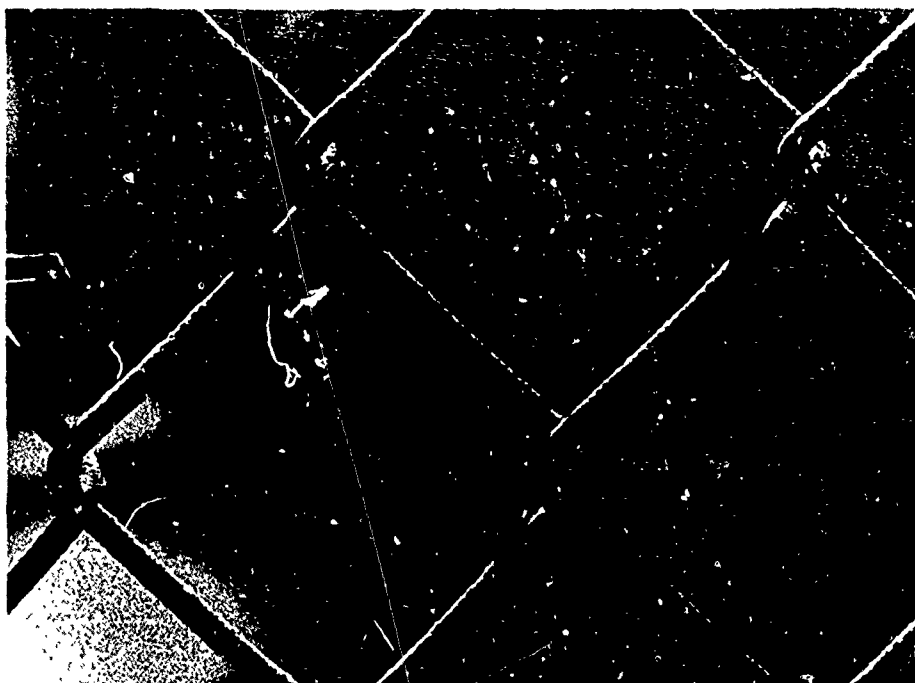
Figure 24. System 3. Aluminum-coated steel - after 12 months of exposure.

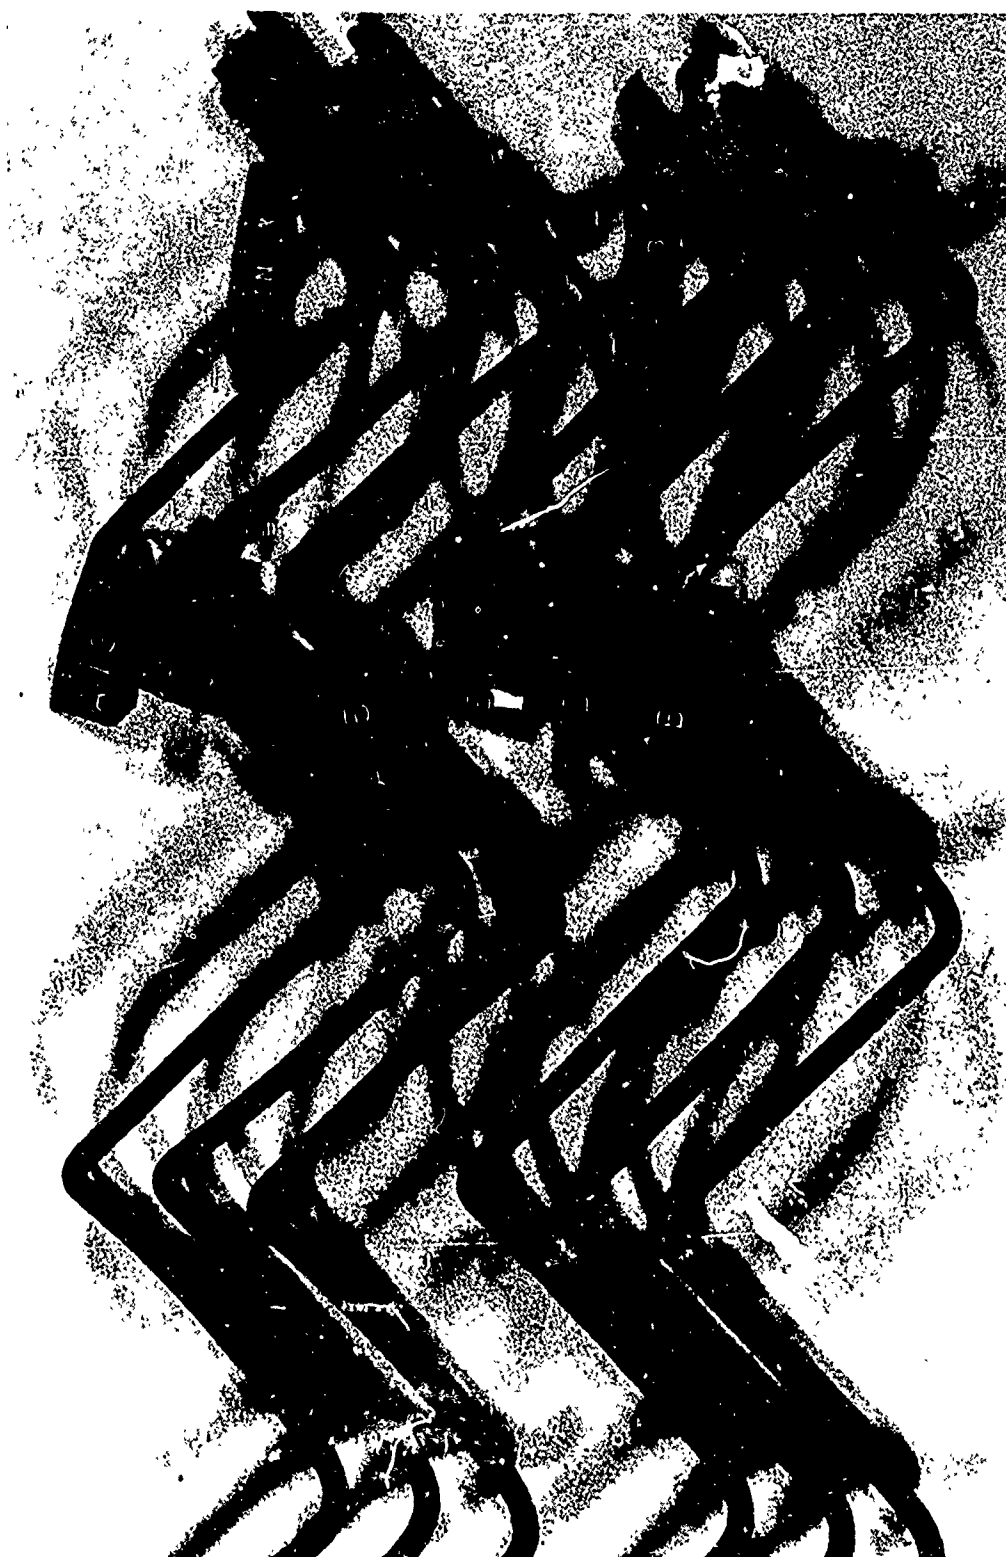
The zinc coating that remained on the wires after 24 months of exposure appeared to be mostly of a dark gray zinc-iron alloy, which had formed between the zinc coating and the base metal during the hot-dip process. This dark zinc-iron alloy is apparently more resistant to corrosion attacks than the zinc coating itself. Although a large percent of the zinc coating was lost, there was protection from rusting in a large area of the base metal (Figure 26).

Figure 26. Systems 1 & 2. Remaining zinc coat after corrosion product was removed - after 24 months of exposure.

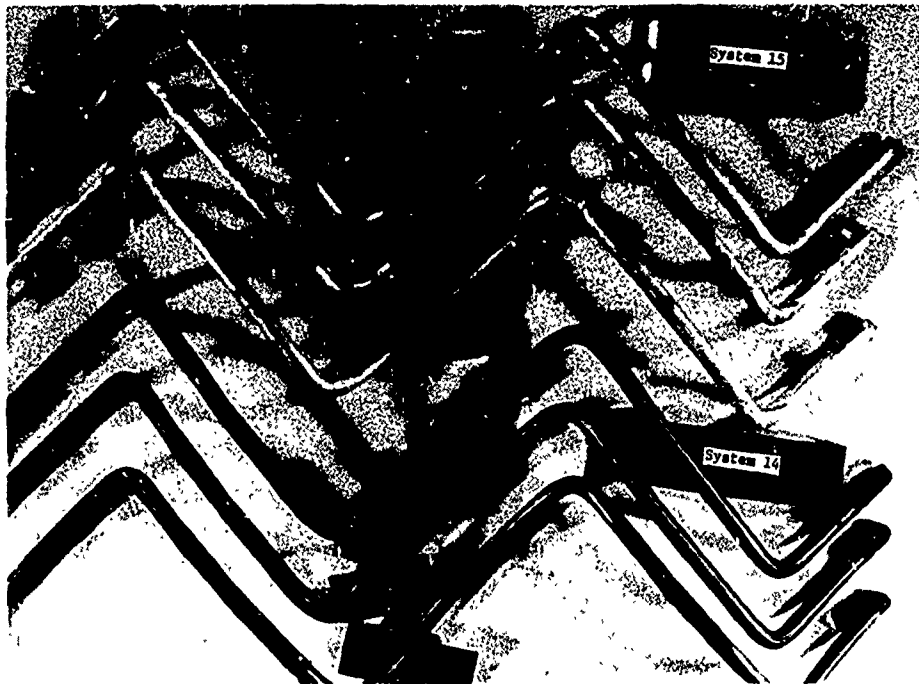
However, after 12 months of exposure, only 45% of the surface of System 15 was covered with a white corrosion product. System 15 lost 0.2 mils or 1.4% of the aluminum coating; this was far less than the loss of coating in Systems 3 and 4 with a comparable length of exposure (Figure 28).

Figure 28. Systems 14 & 15. Remaining aluminum coat and condition of core wire after 12 months of exposure.

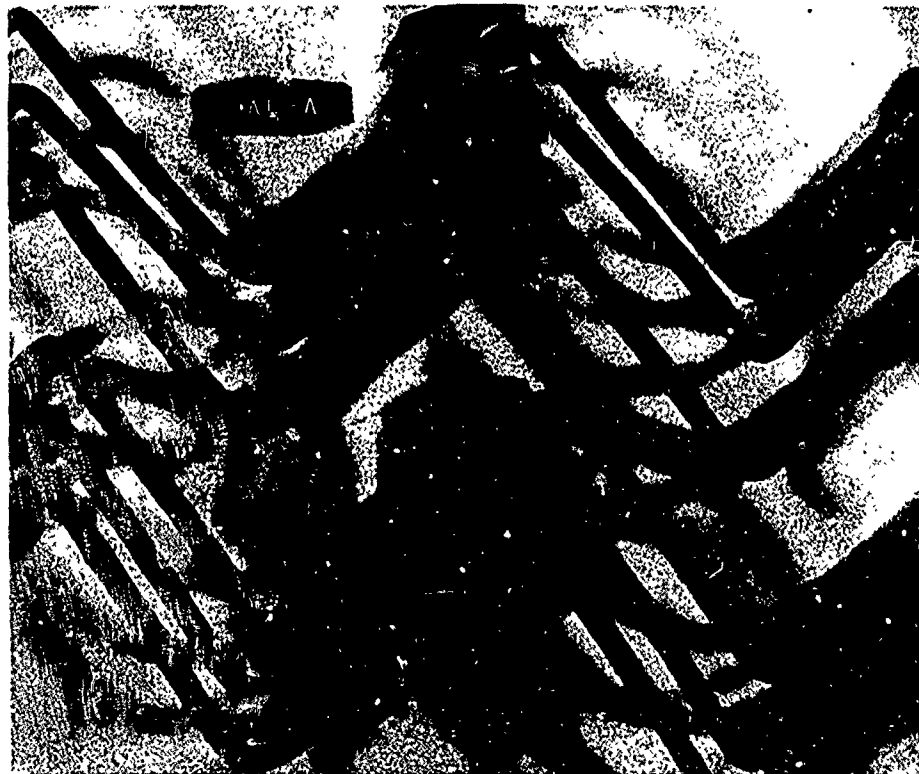
After 24 months of exposure, numerous pin-hole rust stains appeared on the surface of Systems 3 and 4 (Figure 29). System 3 lost an average of 1.8 mils or 61.9% and System 4 lost an average of 2.3 mils or 65.1% of the aluminum coating.

Figure 29. Systems 3 & 4. Aluminum-coated steel - after 24 months of exposure.

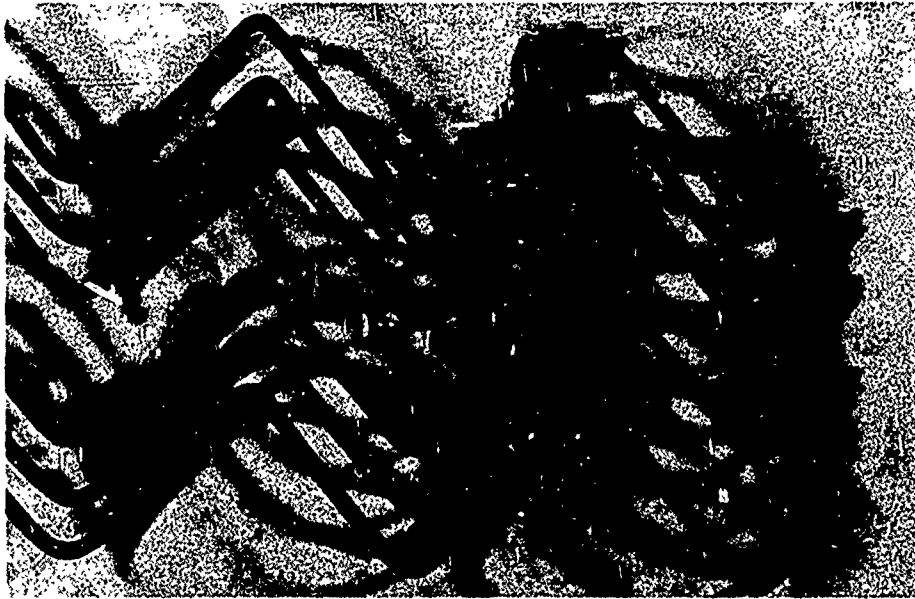
Despite the remaining aluminum coating on wires (Figure 30), the underlying steel core of fence wires was pitted extensively after 24 months of exposure by corrosion attack. The aluminum-coated and zinc-coated wires were stripped of their coatings after 24 months of atmospheric exposure as shown in Figure 31. Figure 31 indicates that the zinc coating protects the underlying steel core until all of the zinc is sacrificially used up, and that the aluminum coating is not as effective in providing sacrificial protection as the zinc coating to protect the underlying steel core. As a result, the underlying steel core was attacked and pitted by corrosion while some of the aluminum coating still remained on the surface of the wire.

Figure 30. Systems 3 & 4. Remaining aluminum coating after corrosion product removed - after 24 months of exposure.

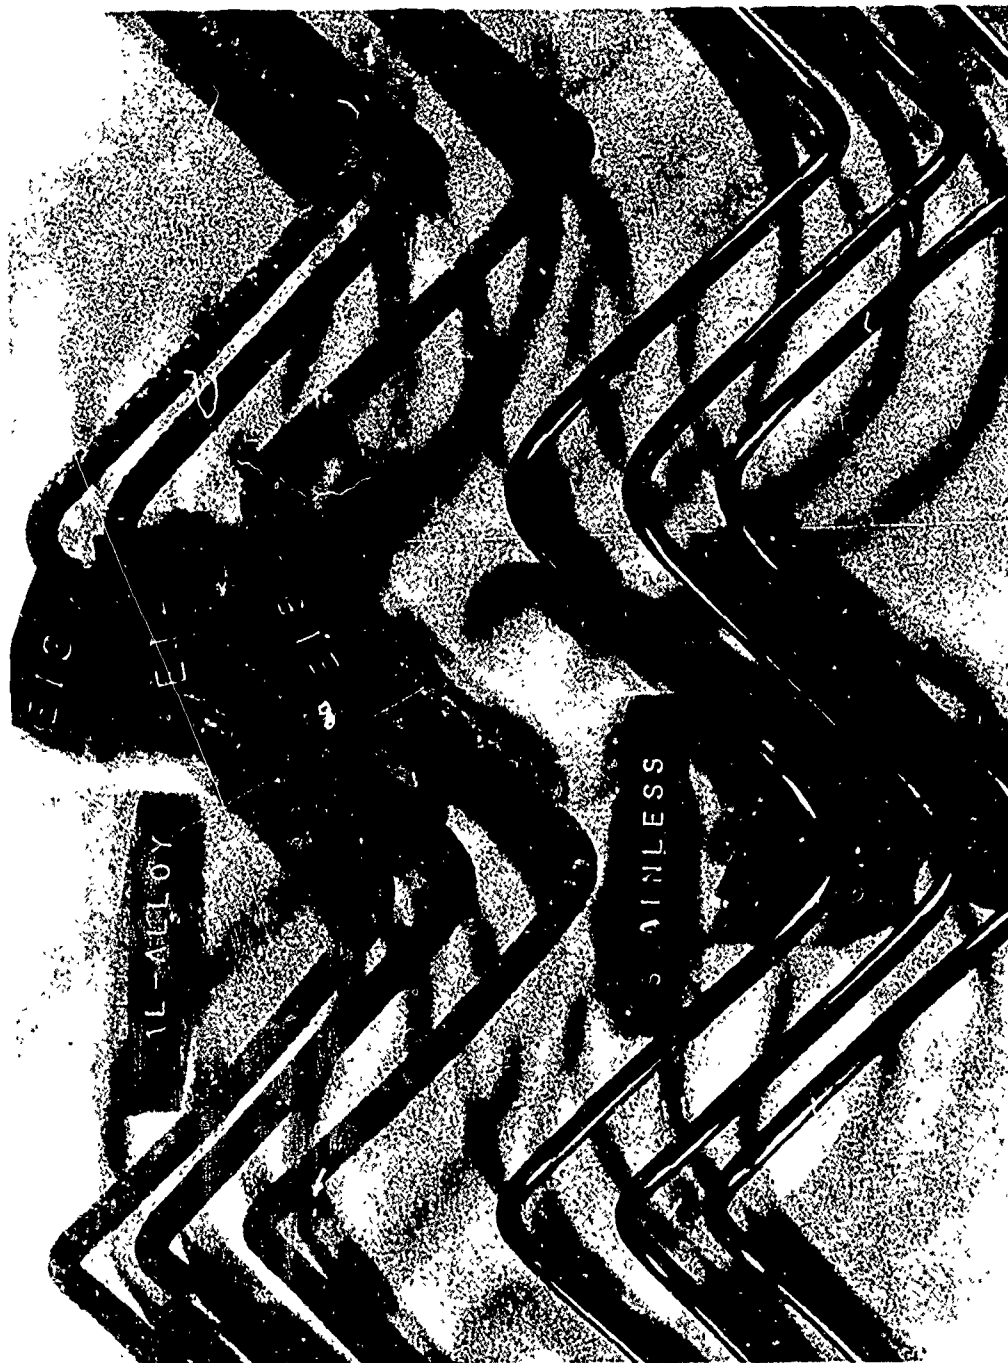
Aluminum Alloy Wire, System 8: After 24 months of exposure, the surface was completely covered with a white corrosion product and air-borne sand and dirt (Figure 32). Aluminum alloy wires lost an average of 0.5% and 1.2% of its weight after 12 and 24 months of atmospheric exposure, respectively.

Most of the corrosion of the aluminum alloy wires was in the form of pin-hole pitting. Thus, depth of penetration was deep, although the amount of metal lost was very light. The corrosion rate obtained by the amount of weight loss in metals as shown in Table 4 is therefore misleading because the corrosion rate so obtained will be much less than the actual penetration of pin-hole pitting. Although the amount of metal weight lost was small, the penetration of some of the pin-hole pittings were as deep as 2 mils or more when examined under a microscope.

Figure 32. Systems 6 & 9. Aluminum alloy and stainless steel wires - after 24 months of exposure.

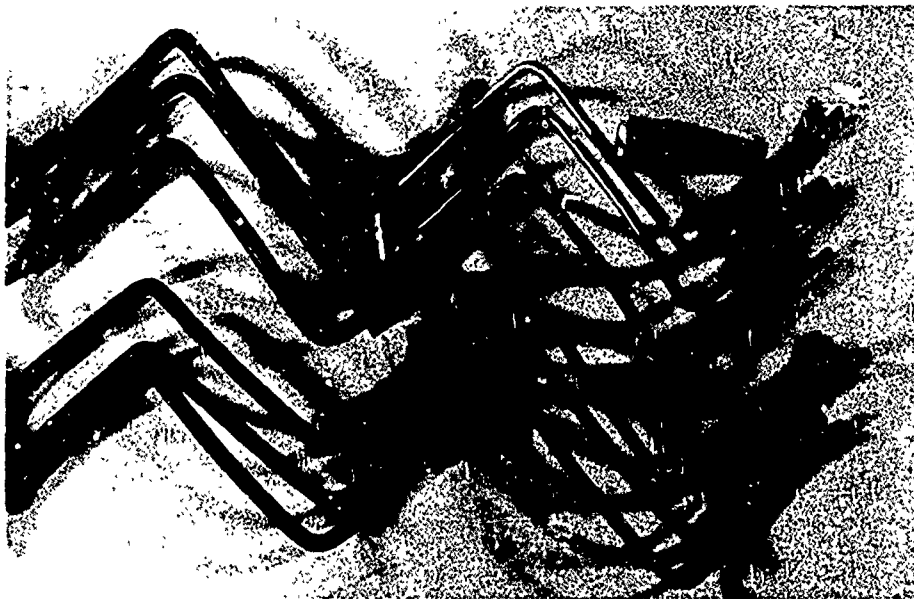
The corrosion rate of the vinyl-coated wires was determined by the weight gain method as described in an earlier section of the report. The results are listed in Table 6. A graphical illustration of the corrosion rate of vinyl-coated wires during the 24 months of atmospheric exposure is shown in Figure 33. Although visual inspection of the test fence did not reveal the condition of core wire, the graph shows that System 5 is the most corrosion-resistant system compared to Systems 7 and 14. System 7 appeared to be corroding faster than the other two systems. System 5 gained 7.1 mg while Systems 7 and 14 gained 76.2 and 31.6 mg of the corrosion product, respectively, during the 12 months of exposure. There was no apparent red-rust accumulation in the inter-space between the vinyl-coating and the core wire of System 5, except for the white corrosion product found near the cut end and scribed area, when the underlying core wire was examined after removing the vinyl coating (Figure 34). Most of the core wires of Systems 7 and 14 were also well protected from corrosion and maintained the original metallic appearance, except near the cut-ends and scribed areas (Figures 28 and 34).

Figure 34. Systems 5 & 7. Condition of core wire after 24 months of exposure.

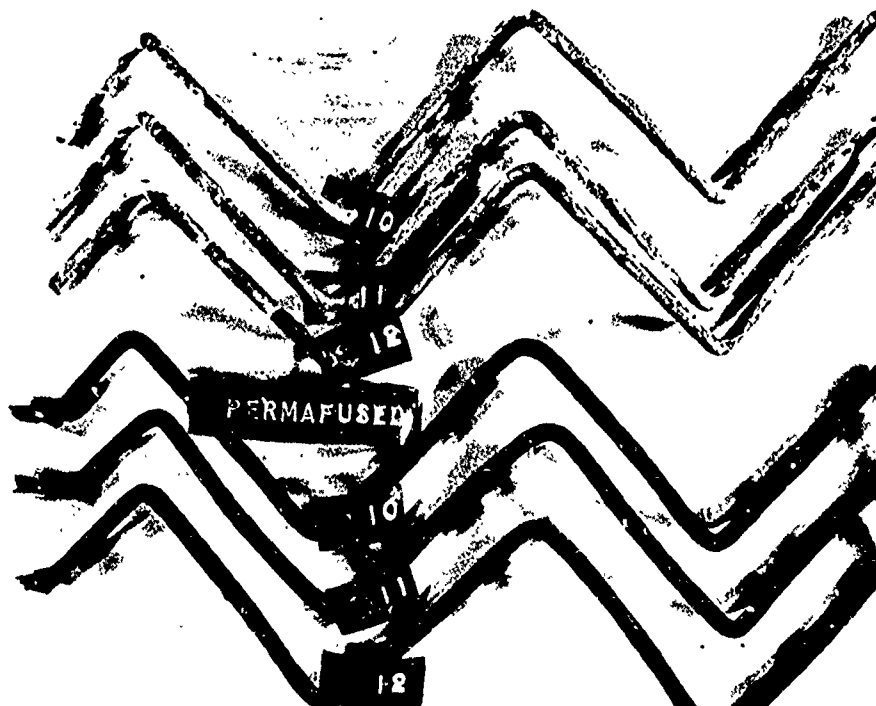
Aluminum-welded wire, System 15: After 4 months of salt-spray exposure, approximately 25% of the surface was covered with a white corrosion product (Figure 35). Except for a small amount of red rust at the cut ends and scribed areas, there was no other red rust on the wires. System 15 was very corrosion-resistant and lost very little of the aluminum coating in comparison with the aluminum-coated wire (System 4) which received extensive pitting corrosion during the comparable length of salt-spray test (Figure 36 vs 37).

Figure 35. Systems 14 & 15 - after 4 months of salt-spray test.

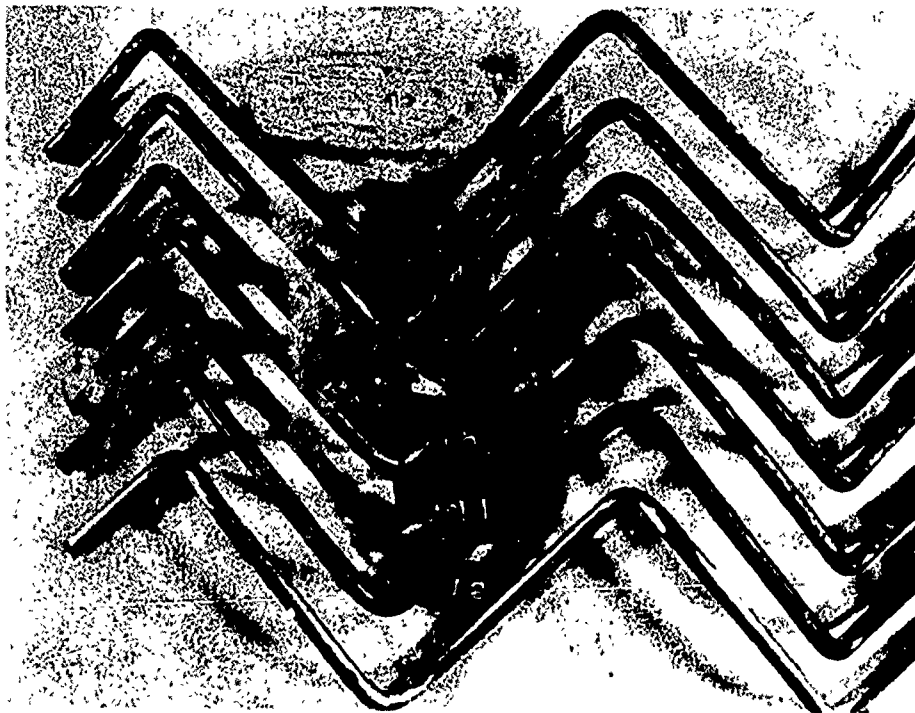
Figure 36. System 15. Corrosion product removed after 2 to 4 months of salt-spray test.

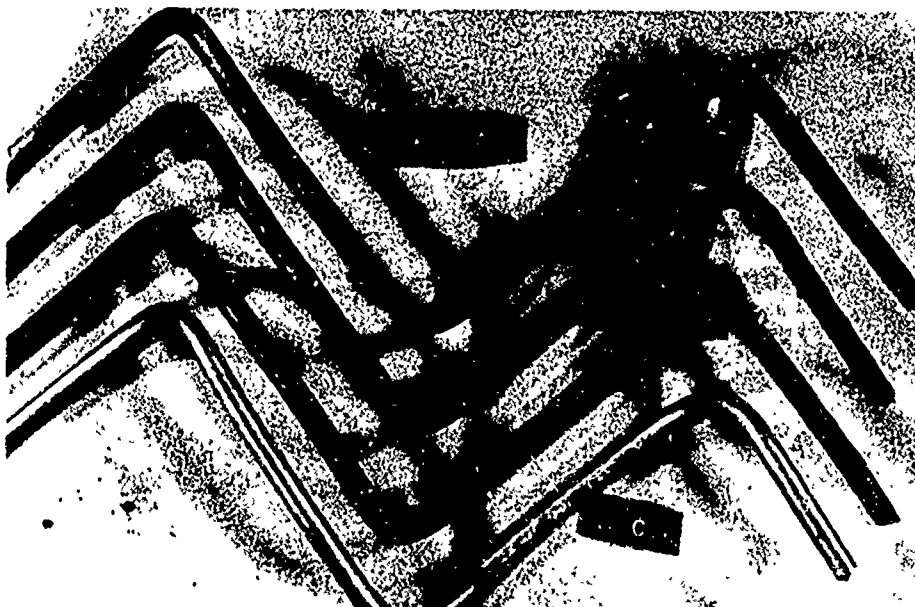
Figure 37. System 4. Corrosion product removed after 4 months of salt-spray test.

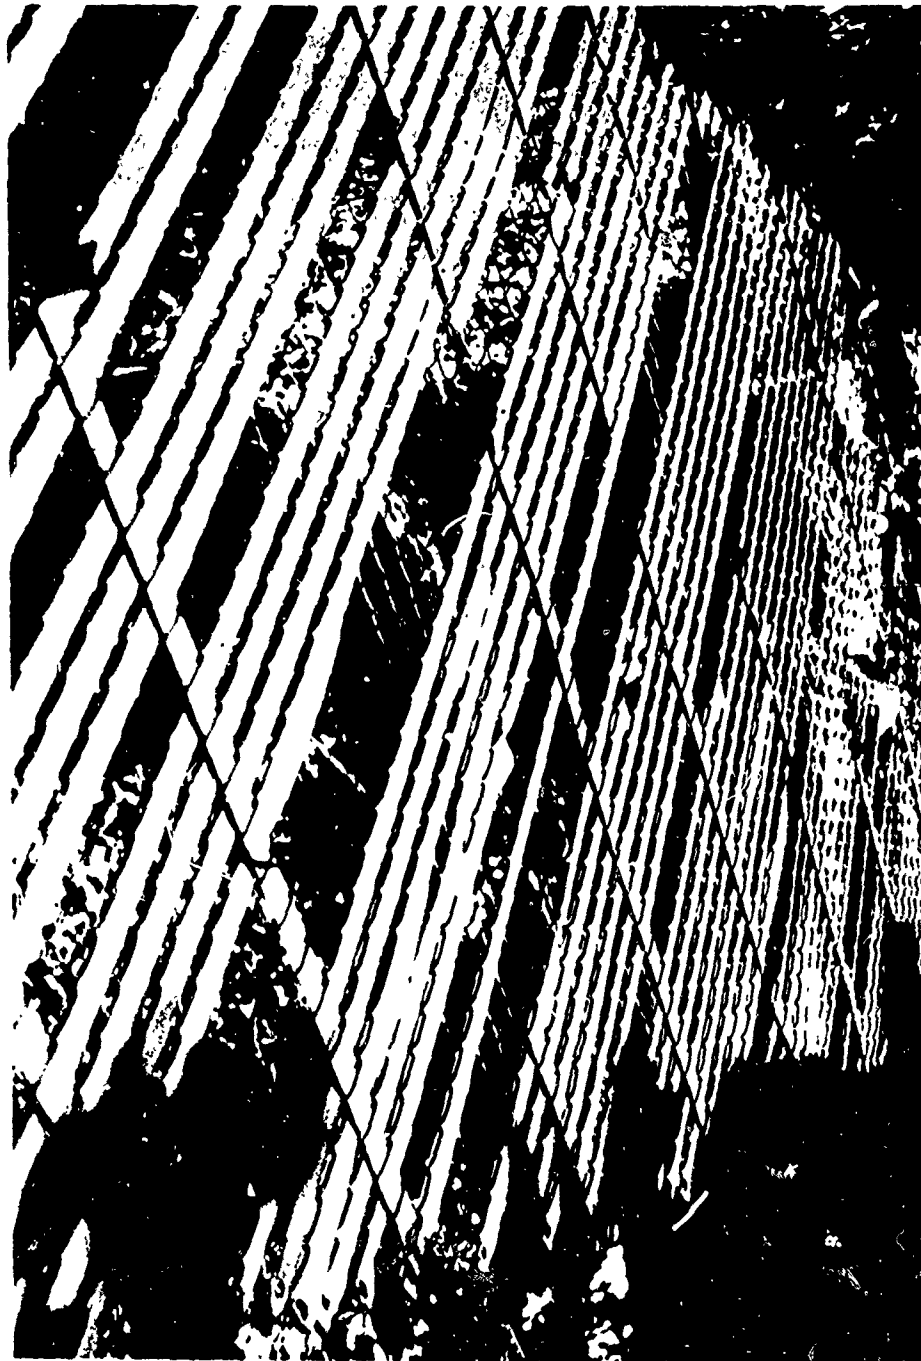
Within 2 weeks following the installation, the aluminum slats of Systems 12 and 13 were damaged by vandalism as reported in reference 2. The damaged and dislodged slats were later replaced by spring-tempered aluminum alloy slats coated with baked enamel. The new slats were not identical to those installed originally. After three years of exposure, small blisters were found on the newly-replaced slats of System 12. Most of the blisters formed at the edges of slats where they contacted each other (Figure 18). The corrosion was accelerated at those contact points because of the entrapment of sand and hygroscopic dirt which in turn retain moisture for a prolonged time and set up a local concentration cell.

Figure 38. Aluminum slats damaged and dislodged by vandalism at nearby Naval base.
